# LAKE HOUSATONIC DAM AND DIKE

CT 00026

## PHASE I INSPECTION REPORT NATIONAL DAM INSPECTION PROGRAM

AUGUST 1981

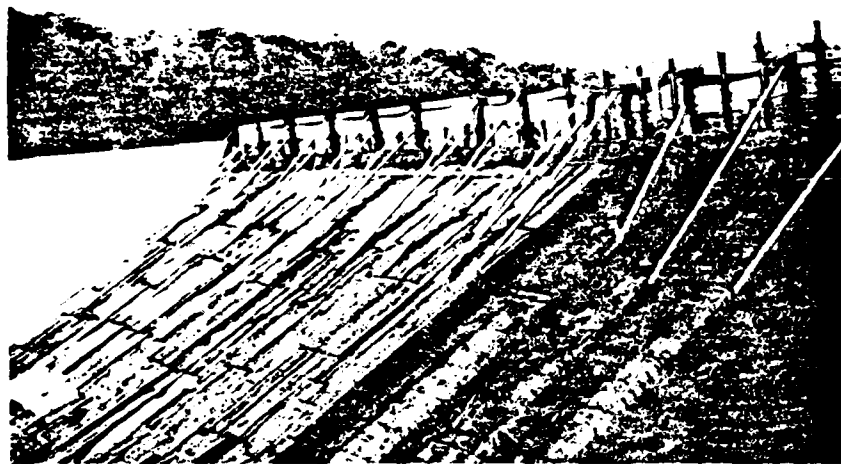
DERBY DAM - Oct 1948  
REMOVING TIMBER APRON PRIOR TO  
POURING CONCRETE

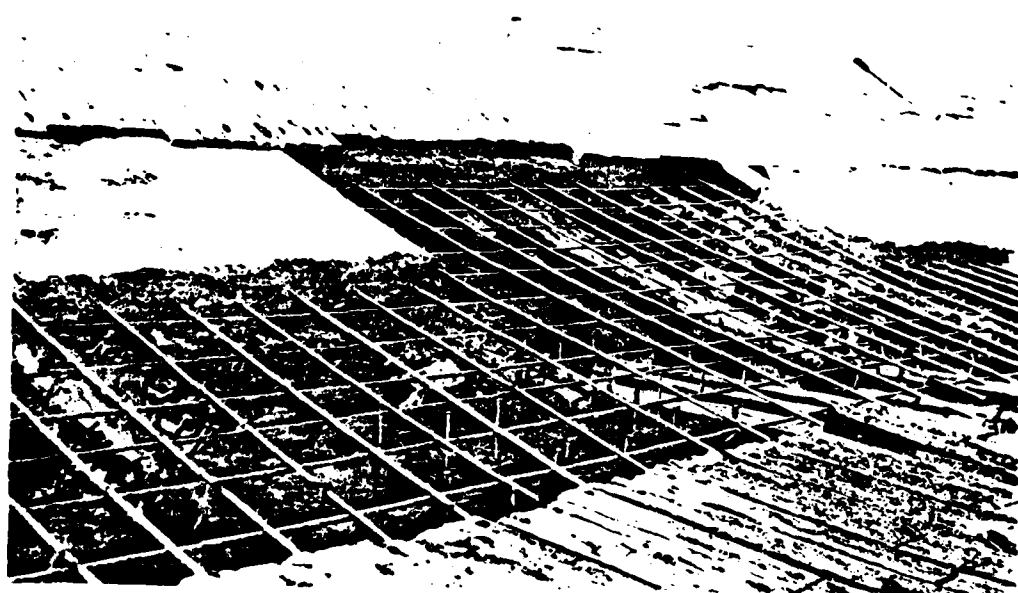
DERBY DAM - Oct 1948  
APRON REPAIRS SHOWING REINFORCING  
PRIOR TO POURING CONCRETE

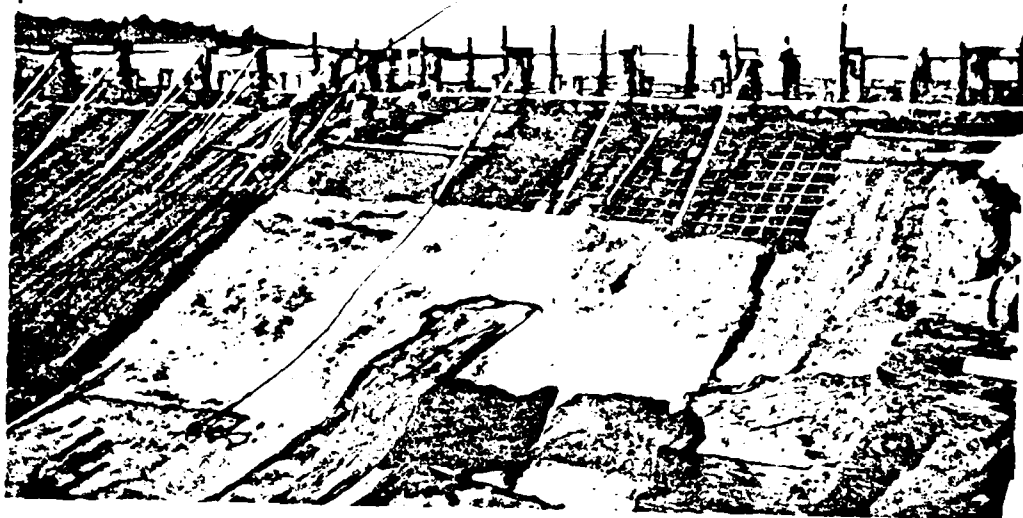
DERBY DAM Oct 1948  
POURING CONCRETE APRON
